Manhole Inspection Summary

Manhole # S05UU1011MH

Insp Date: **9/26/06 1:10 PM**

Location Address: **5710 HIGHGATE DR**

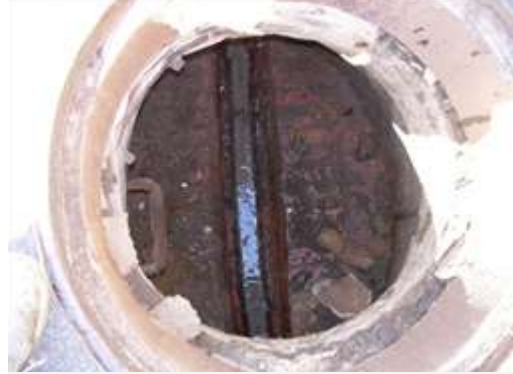
Comments **The Top View photo shows grease in the Channel. The O12 pipe picture shows Barrel deterioration and infiltration.**

Frame leaks. Frame offset. Adjustment deterioration and loose brick. Corroded and missing steps. Bench debris.

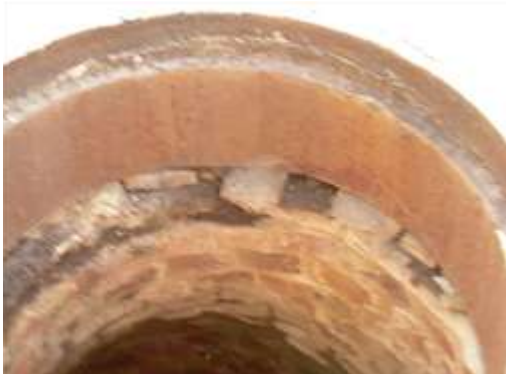
Defect

Frame leaks. Adjustment deterioration, loose brick and infiltration. Corbel and Barrel infiltration.

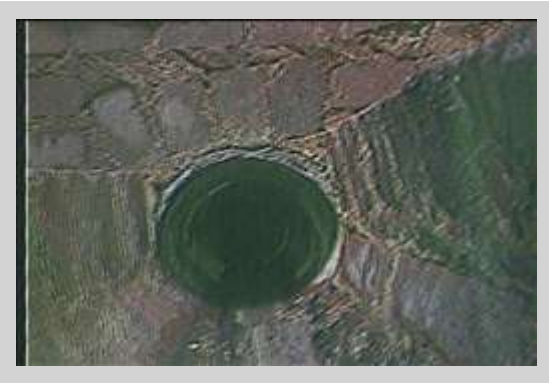
8 in. Circular Gravity Sewer Pipe Out @ 12 O'Clock

Infiltration: **Evidence** Pipe Seal Cond: **Unknown**

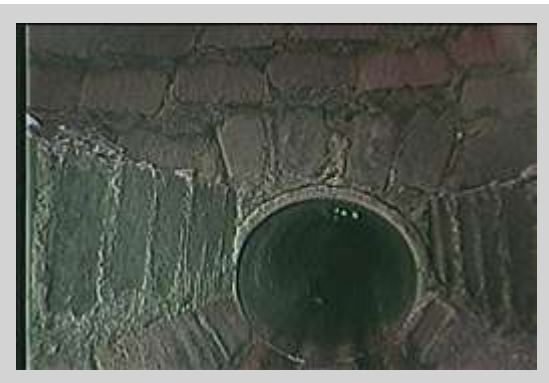
8 in. Circular Gravity Sewer Pipe In @ 6 O'Clock

Infiltration: **Evidence** Pipe Seal Cond: **Unknown**
